Minimally Invasive CT-Guided Retrieval of Marine Foreign Bodies: A Case of Sea Urchin Granuloma

Abstract

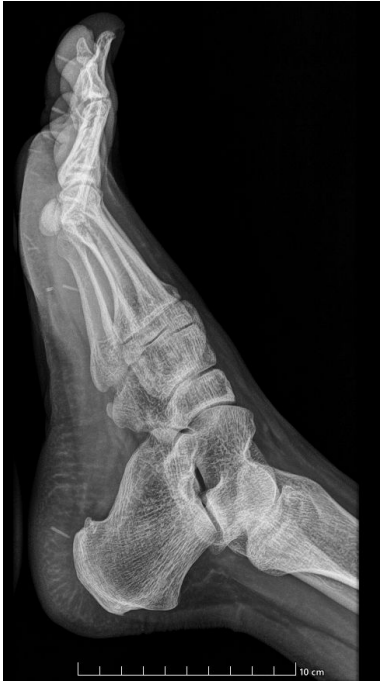
Figure 1: Multiple radiodense spike-like foreign bodies visualized in the soft tissues of the foot on plain radiography, consistent with retained sea urchin spines.

Plain radiographs of the bilateral feet and thighs were obtained. Multiple linear and spike-like radio-opaque foreign bodies were visualized, distributed throughout the soft tissues of the feet and posterior thighs (Figures 1 and 2). These exhibited high radiographic attenuation, consistent with their calcite composition [2]. Based on these findings, the patient was referred back to the surgery outpatient department with precise surface marking to facilitate surgical removal.

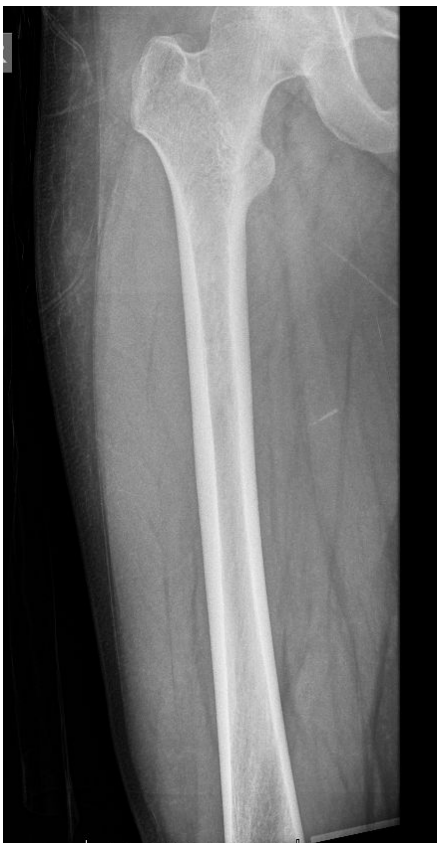
Figure 2: Plain radiograph demonstrating linear hyperdense foreign bodies in the posterior thigh soft tissues.
