RESEARCH PAPER

Groundwater Quality Analysis In Colliguay, Valparaíso Region: A Case Study In Rural Areas Of Central Chile

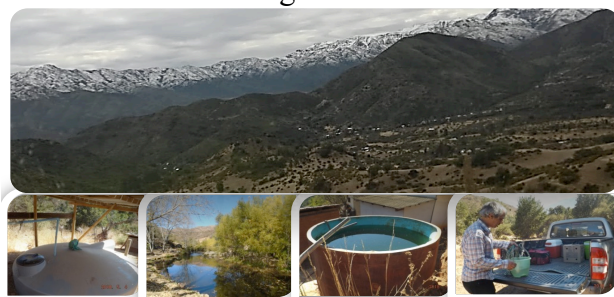
Figure 1. Panoramic photo of Colliguay and some of the wells sampled.

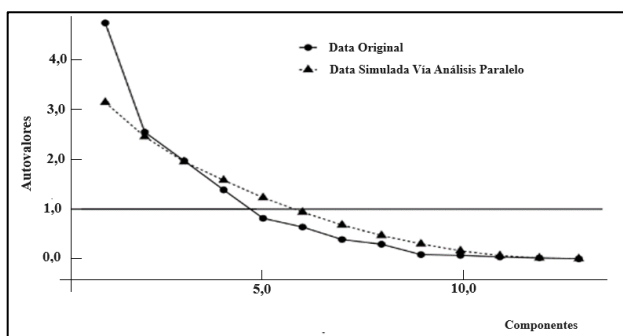
Figure 4. Graph of the eigenvalues resulting from the Principal Component Analysis (PCA), known as the scree plot.

The Principal Component Analysis (PCA) depicted in Figure 4 offers supplementary insights into the interrelationships among the various parameters under consideration. The relationship between water temperature, total hardness, nitrite levels, and other parameters can provide insights into the dynamics of water quality in the wells studied, thus helping to identify key factors influencing the variability observed in the water quality data. [36] employed the principal component analysis (PCA) with Varimax rotation to determine the number of factors to be retained.
